FINAL REPORT *OF* A BOARD OF INVESTIGATION

*To Inquire Into*  
THE DESIGN  
AND METHODS OF CONSTRUCTION  
OF WELDED STEEL MERCHANT  
VESSELS

15 JULY 1946

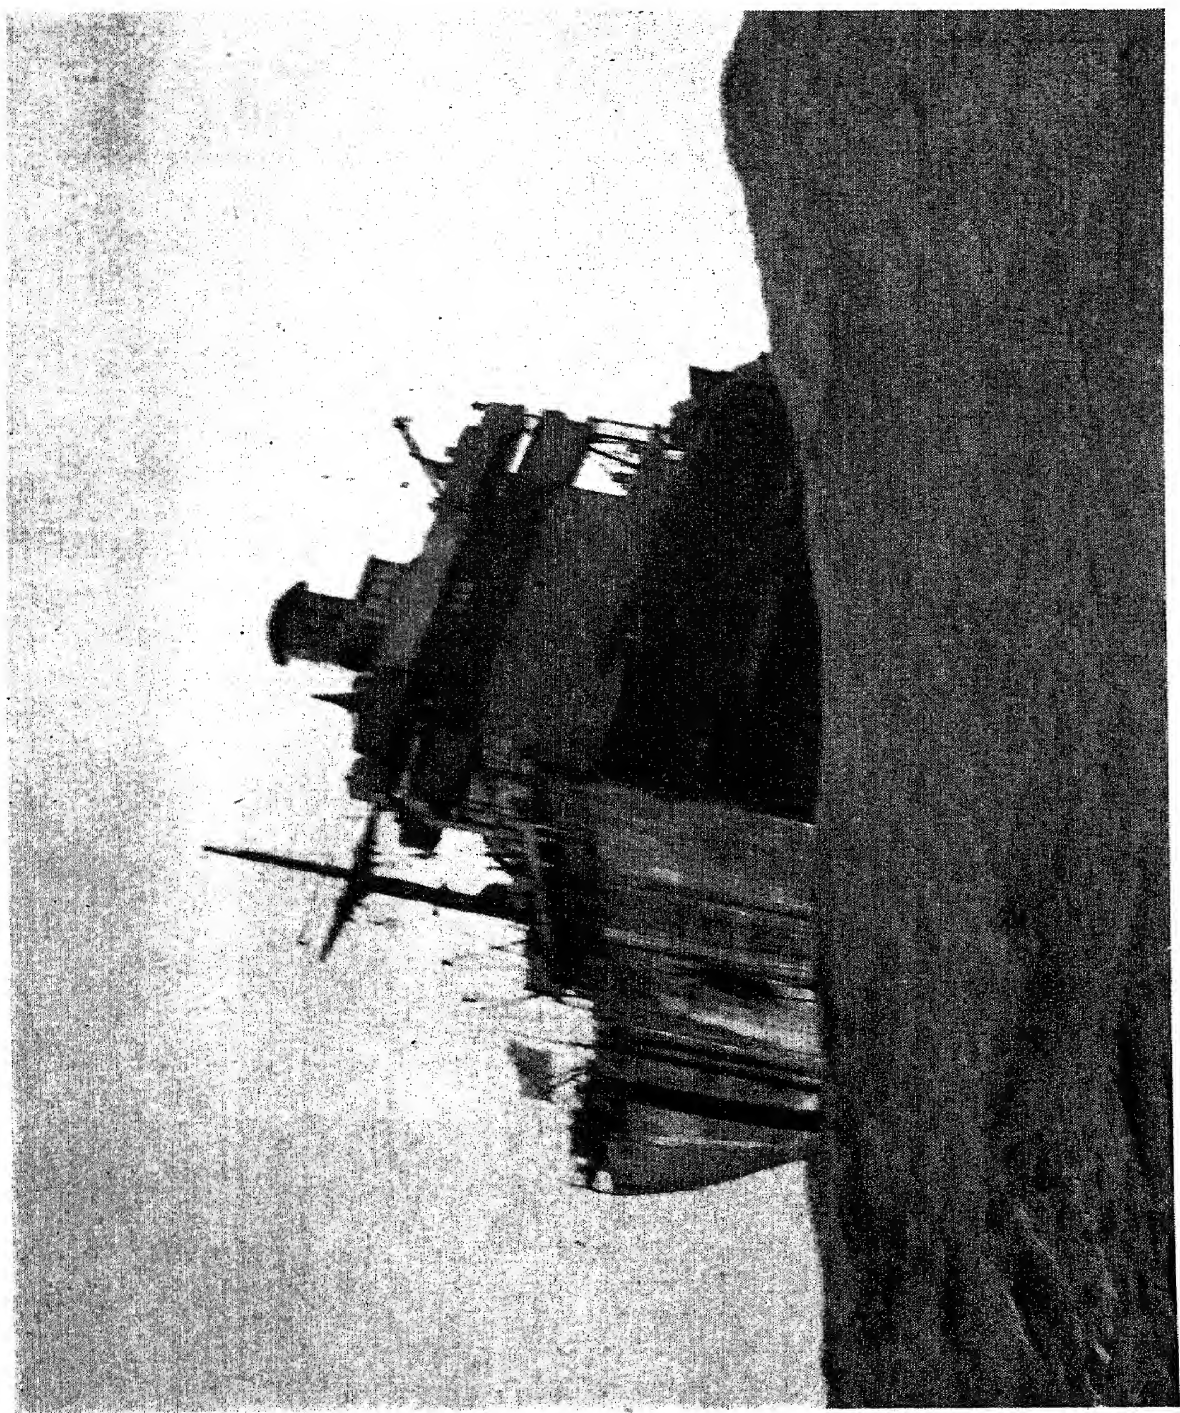
<b>The bow is believed to have sunk. The stern is aground on Big Koniuj Island.</b>	
SIGNED (Name and Title)	DISTRICT

FIGURE 4.—Stern portion of S. S. *John P. Gaines*.

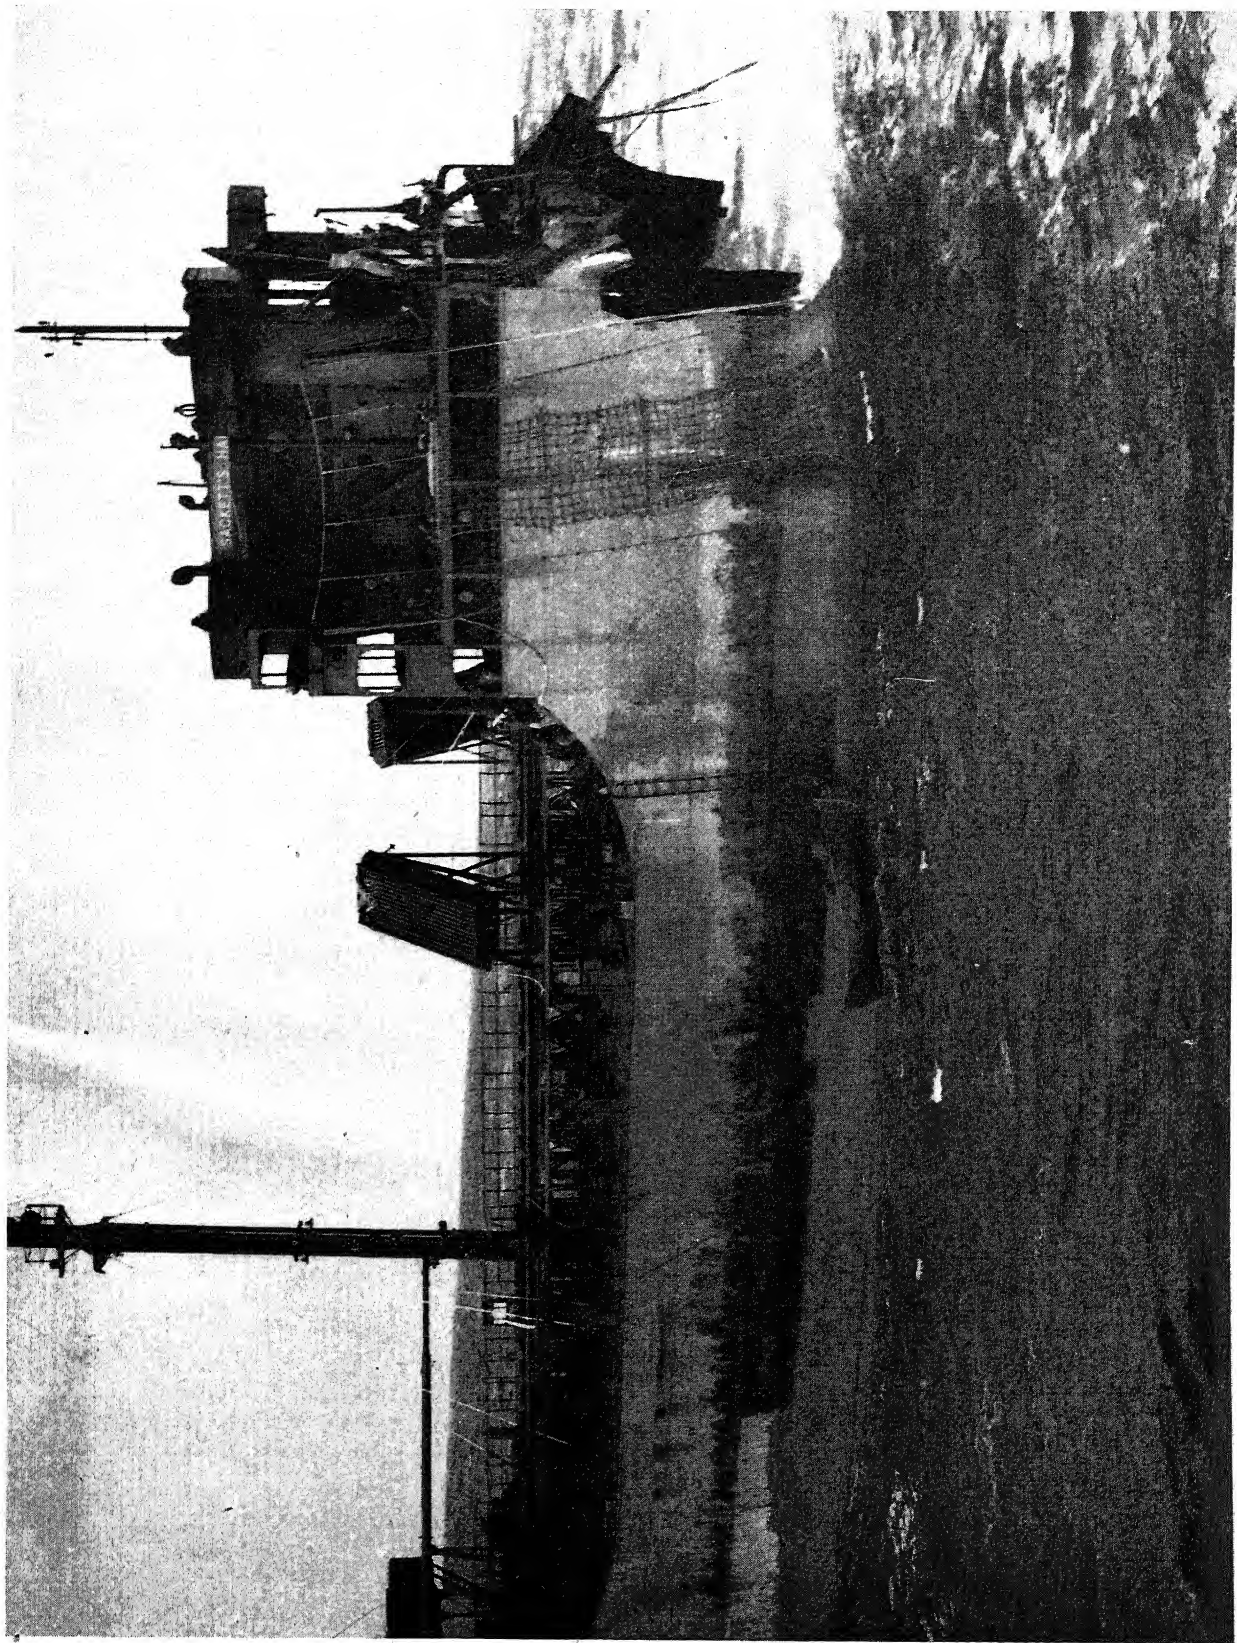
FIGURE 9.—Forward portion of S. S. Sacketts Harbor.

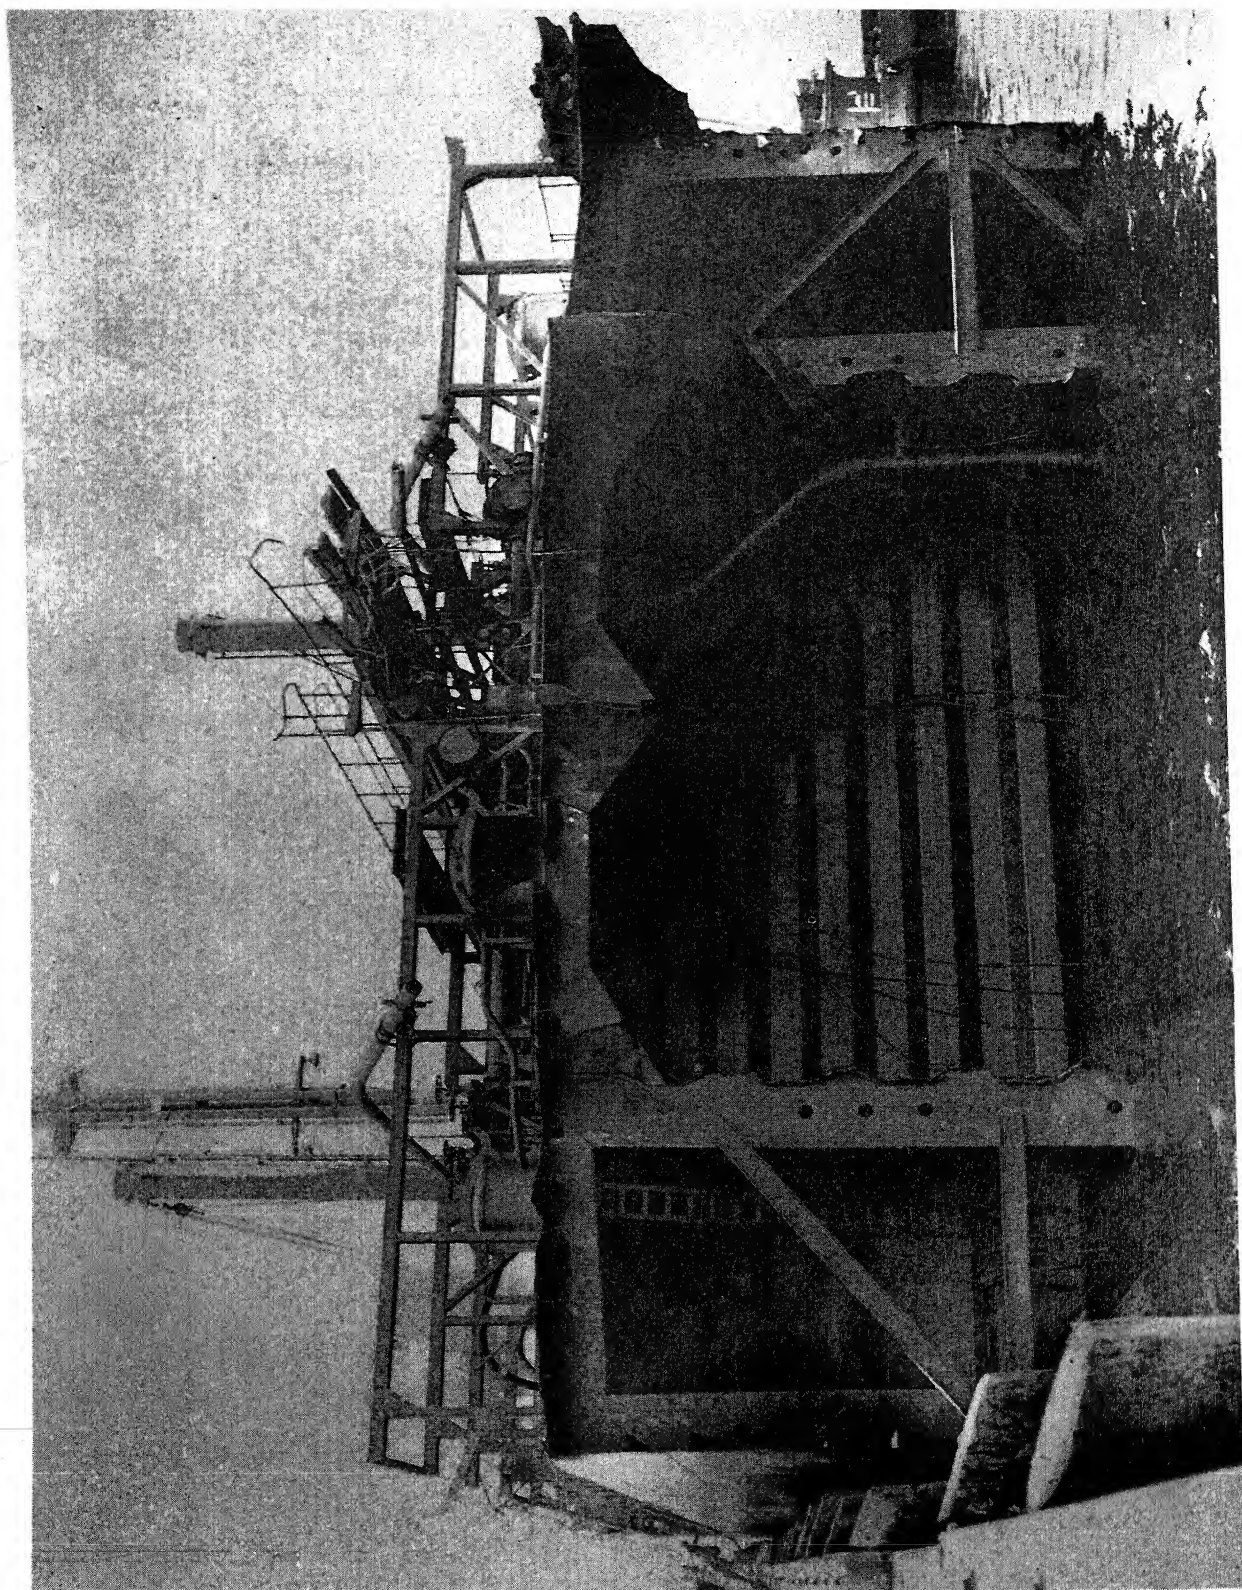
<b>Stern section awaiting tow; bow section sunk by gunfire.</b>	
SIGNED (Name and Title)	DISTRICT

FIGURE 10.—Stern portion of S. S. Sacketts Harbor.

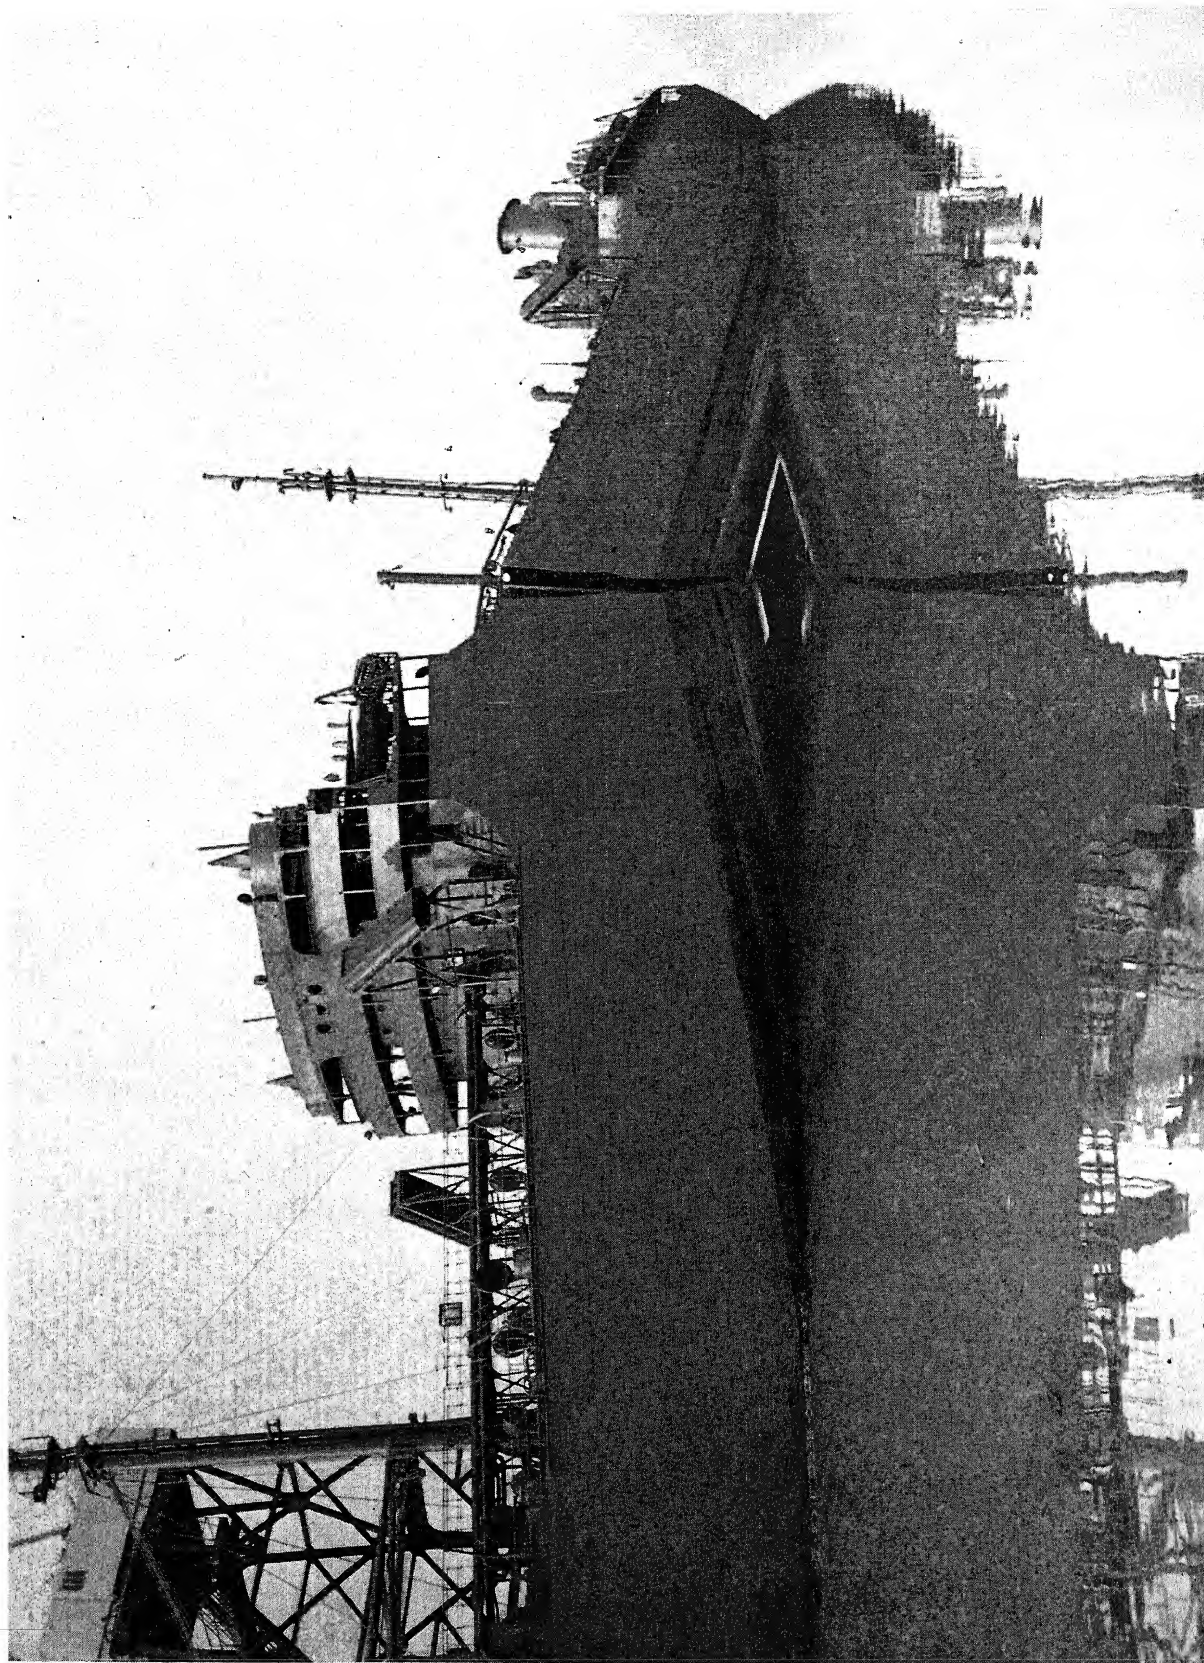
FIGURE 11.—View of S. S. *Schenectady* after splitting in two at her outfitting dock.

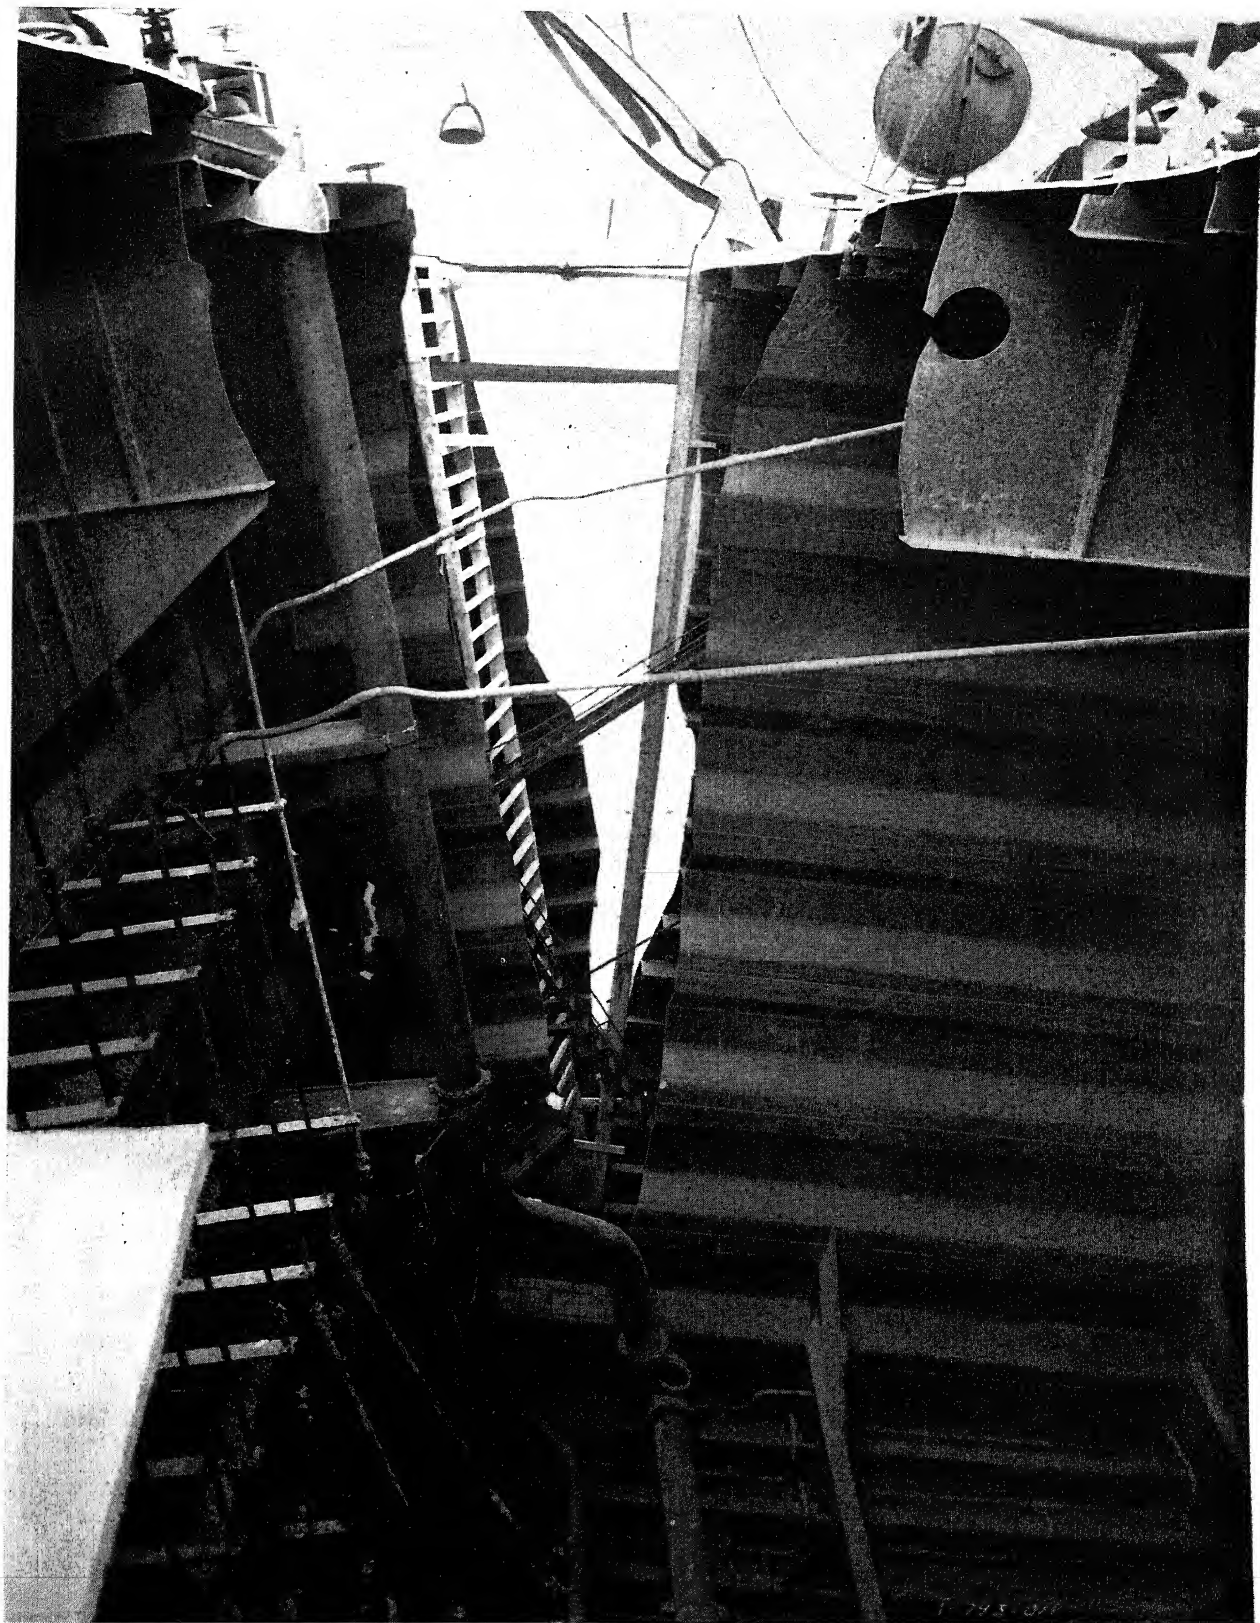
FIGURE 12.—*S. S. Schenectady*, view inside crack showing complete fracture of longitudinal bulkheads.

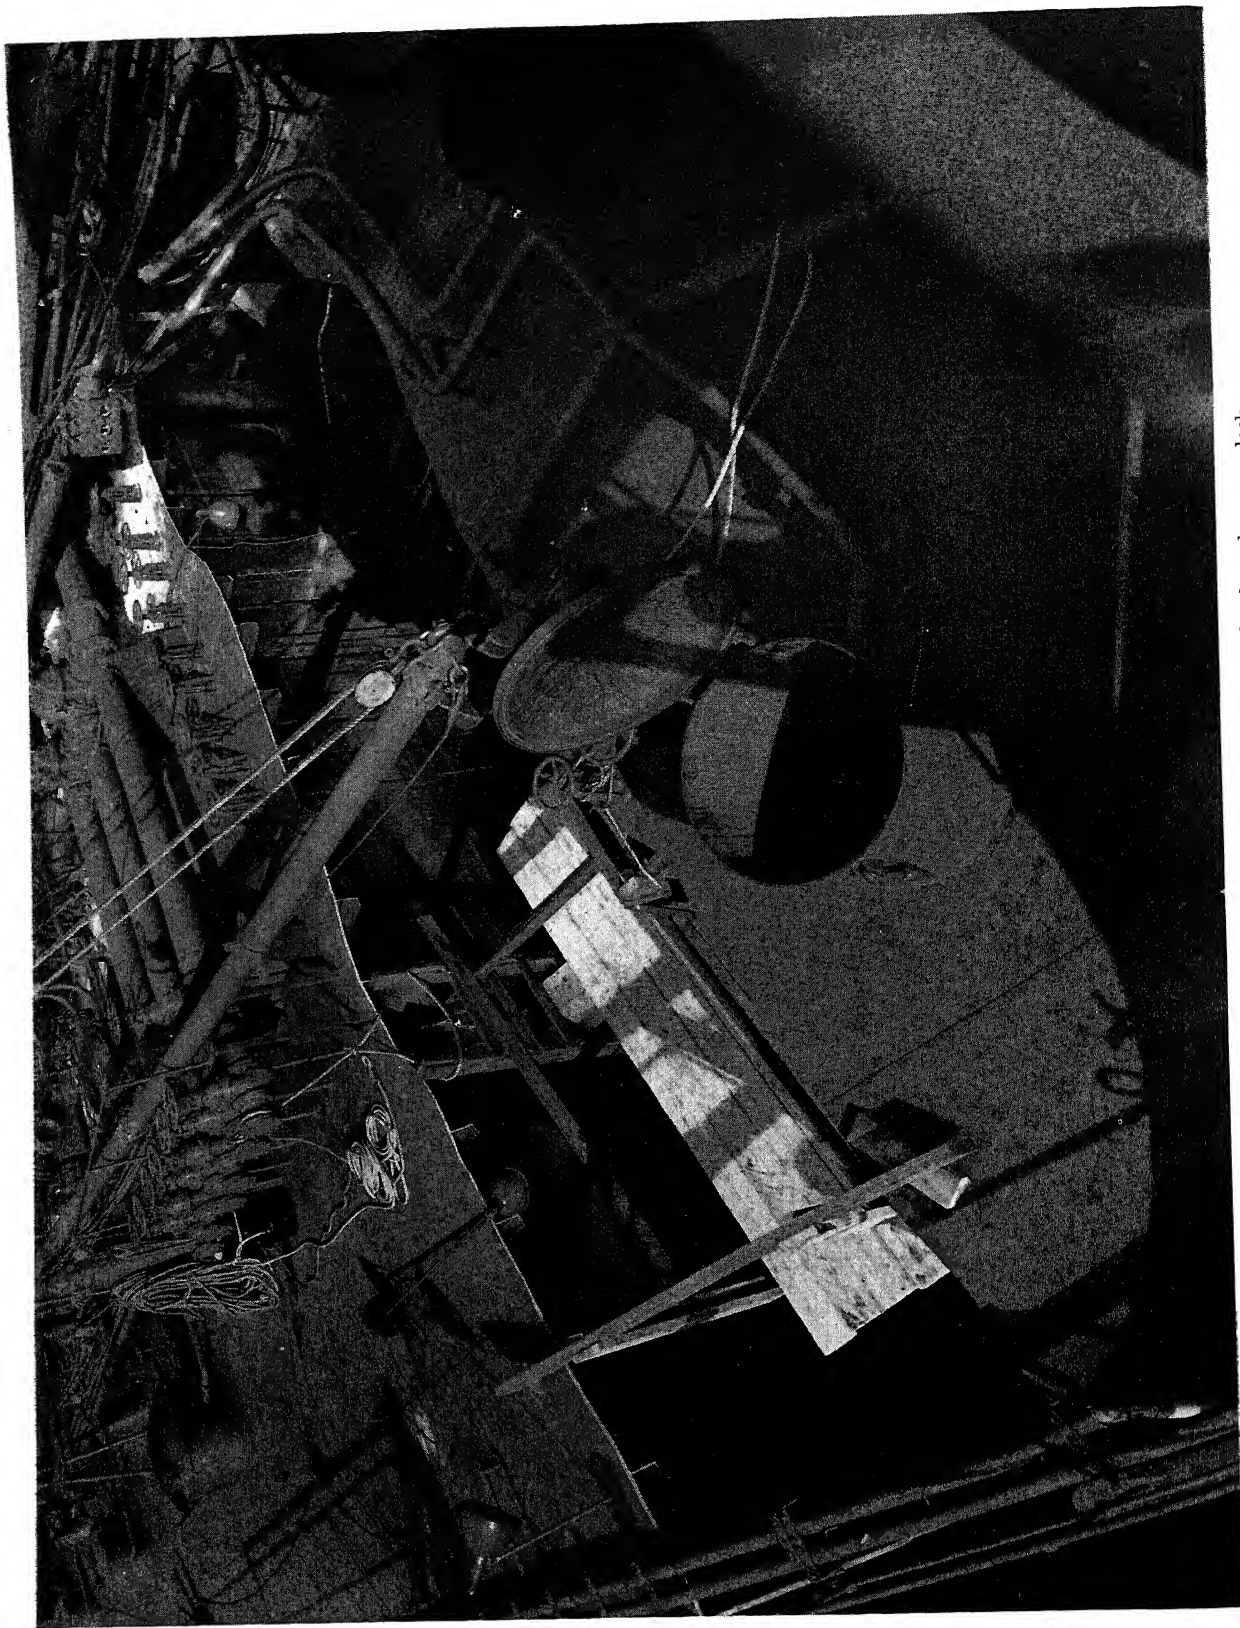
FIGURE 13.—S. S. *Schenectady*, view looking down at inside of crack across deck.

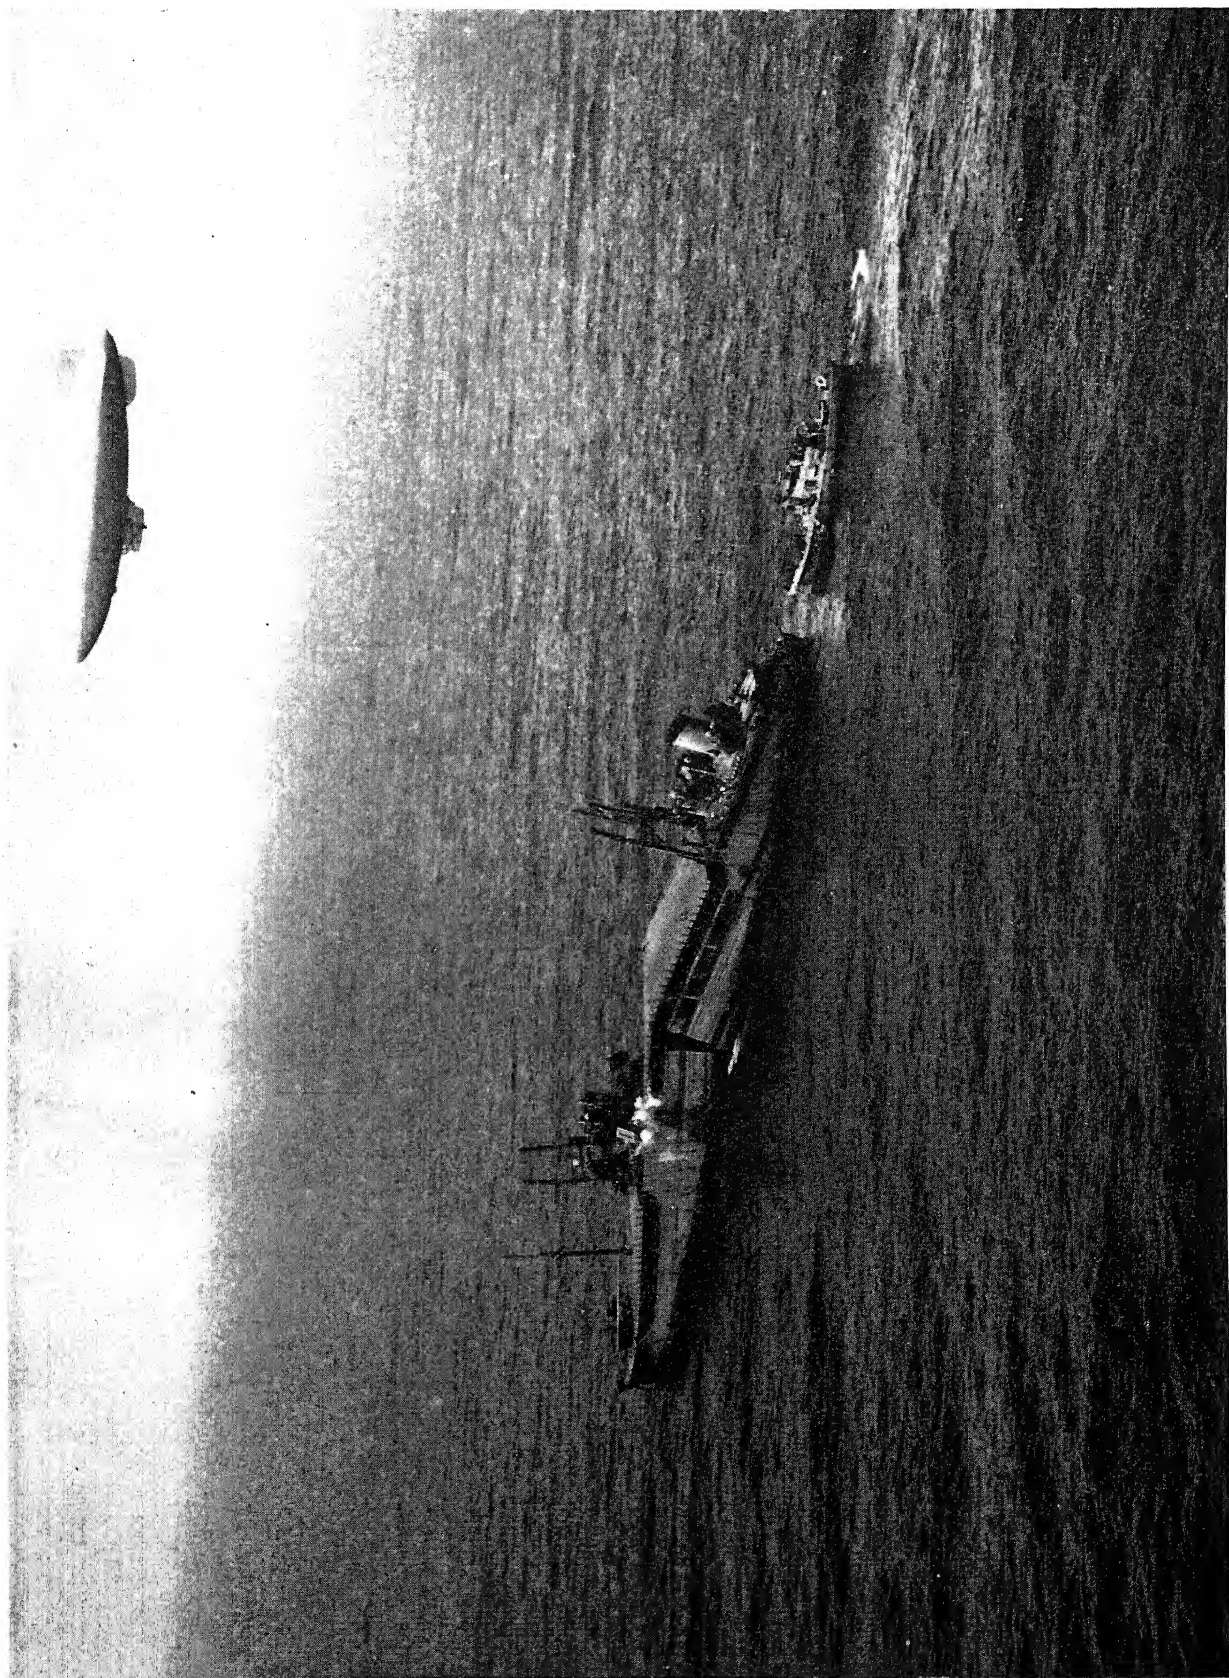
FIGURE 16.—Aerial view of failure of *S. S. Esso Manhattan* taken from one of two blimps conveying vessel.

<b>Repaired on drydock at Todd Erie Basin and returned to service.</b>	
SIGNED (Name and title)	DISTRICT

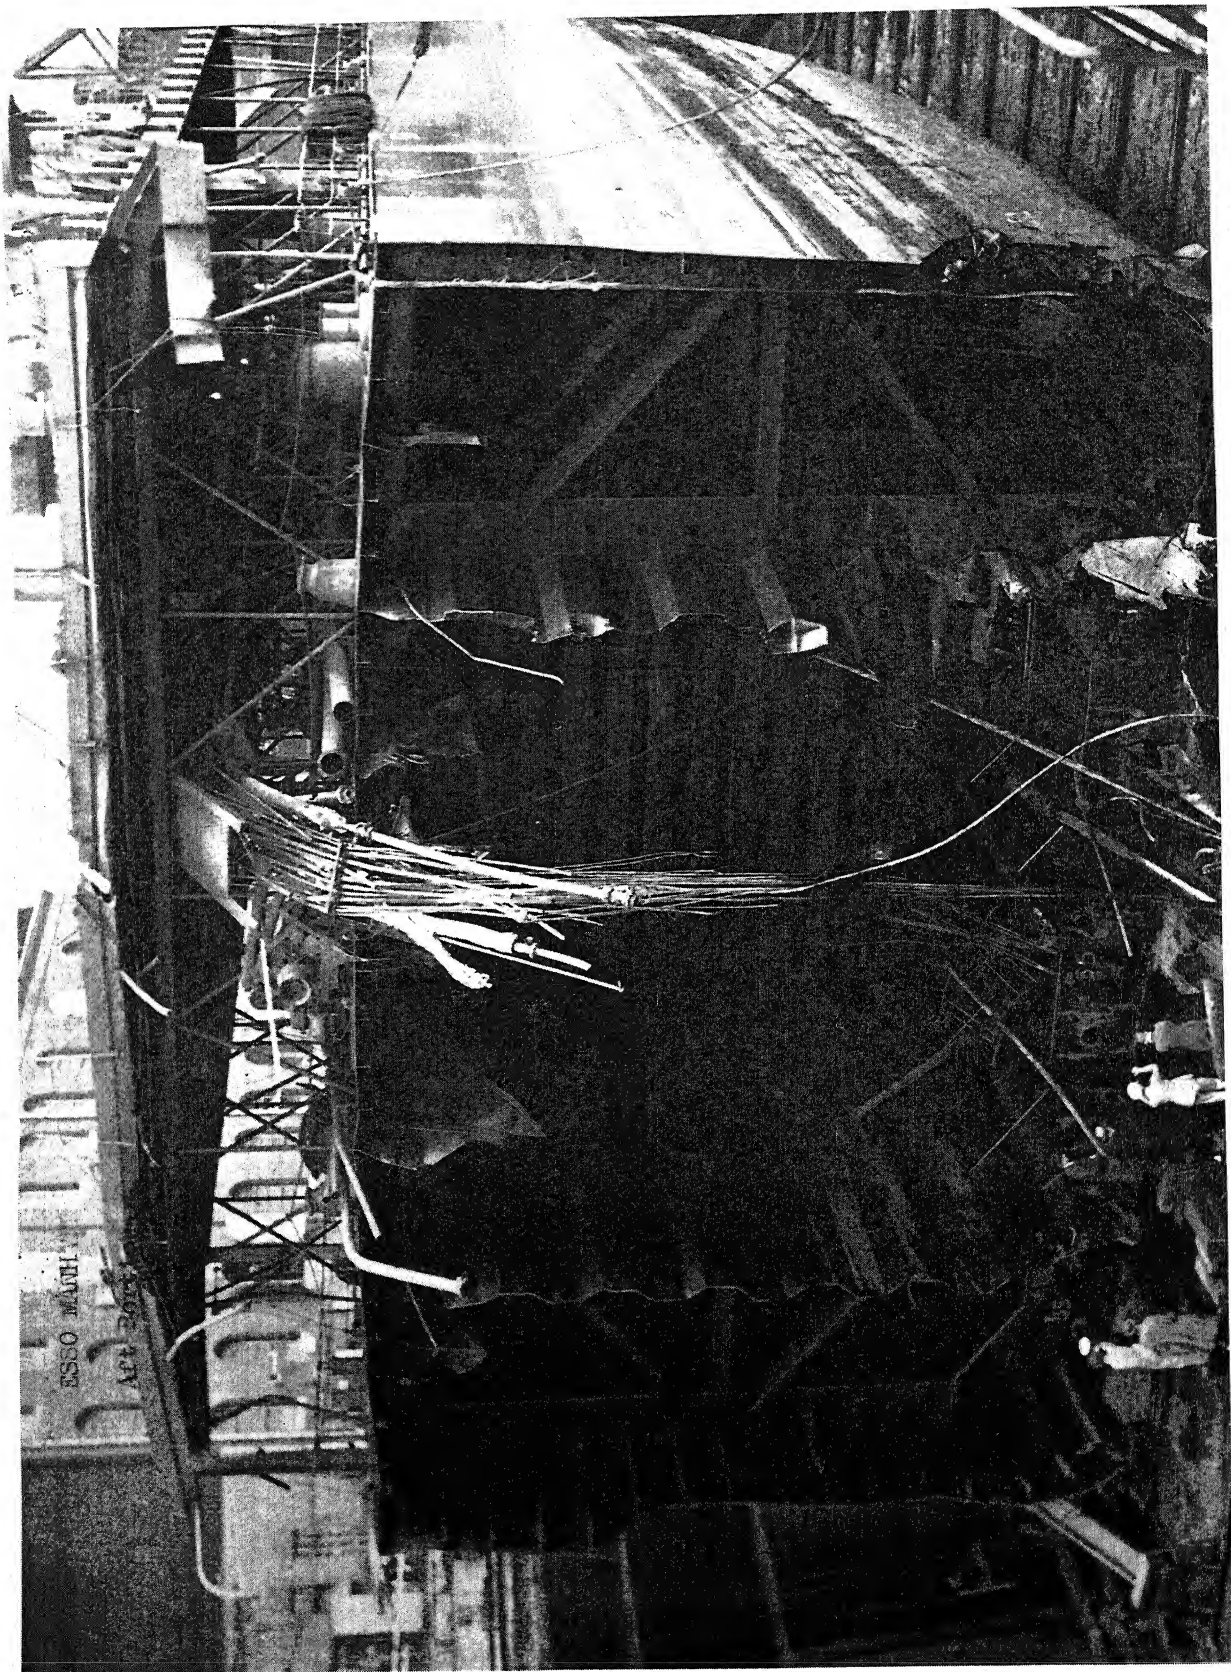
Figure 17.—Aft portion S. S. Esso Manhattan.

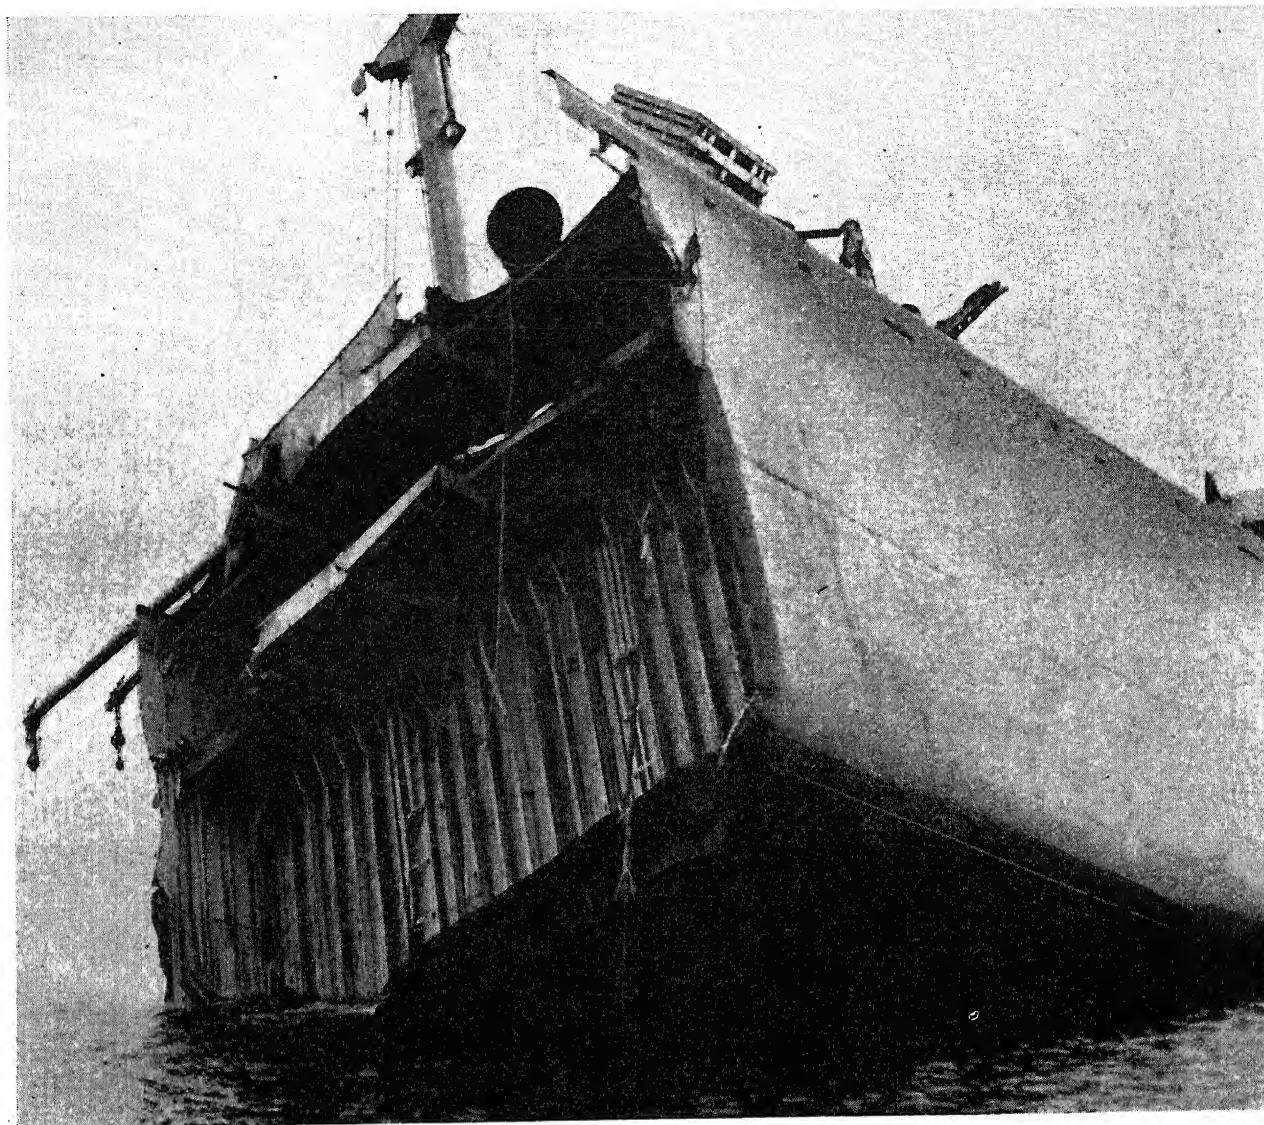
FIGURE 18.—Forward portion of *S. S. Valeri Chkalov*.

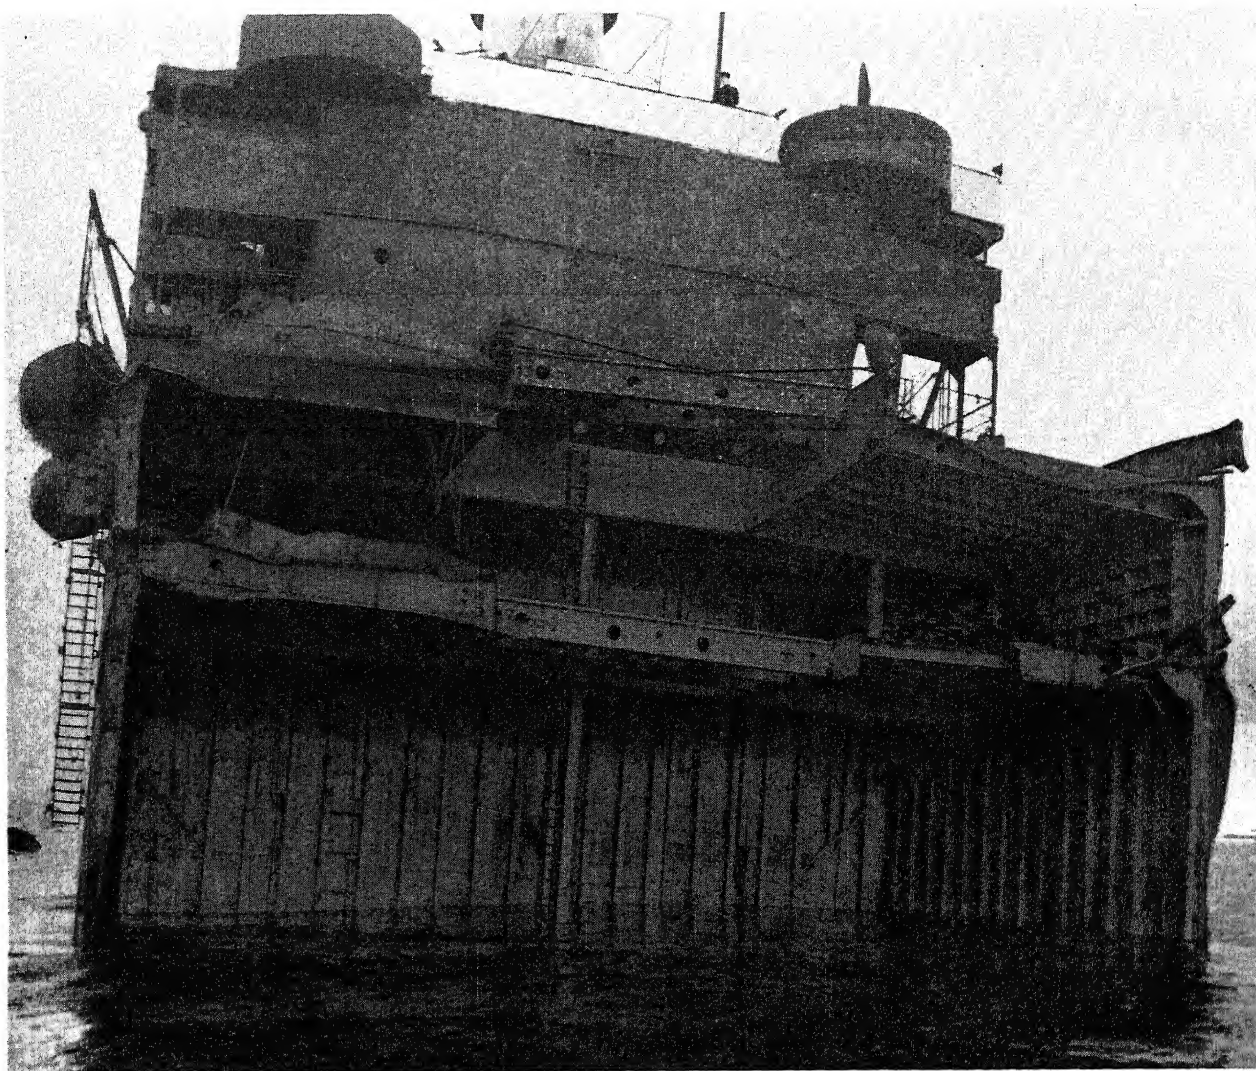
FIGURE 19.—Stern portion of *S. S. Valeri Chkalov*.

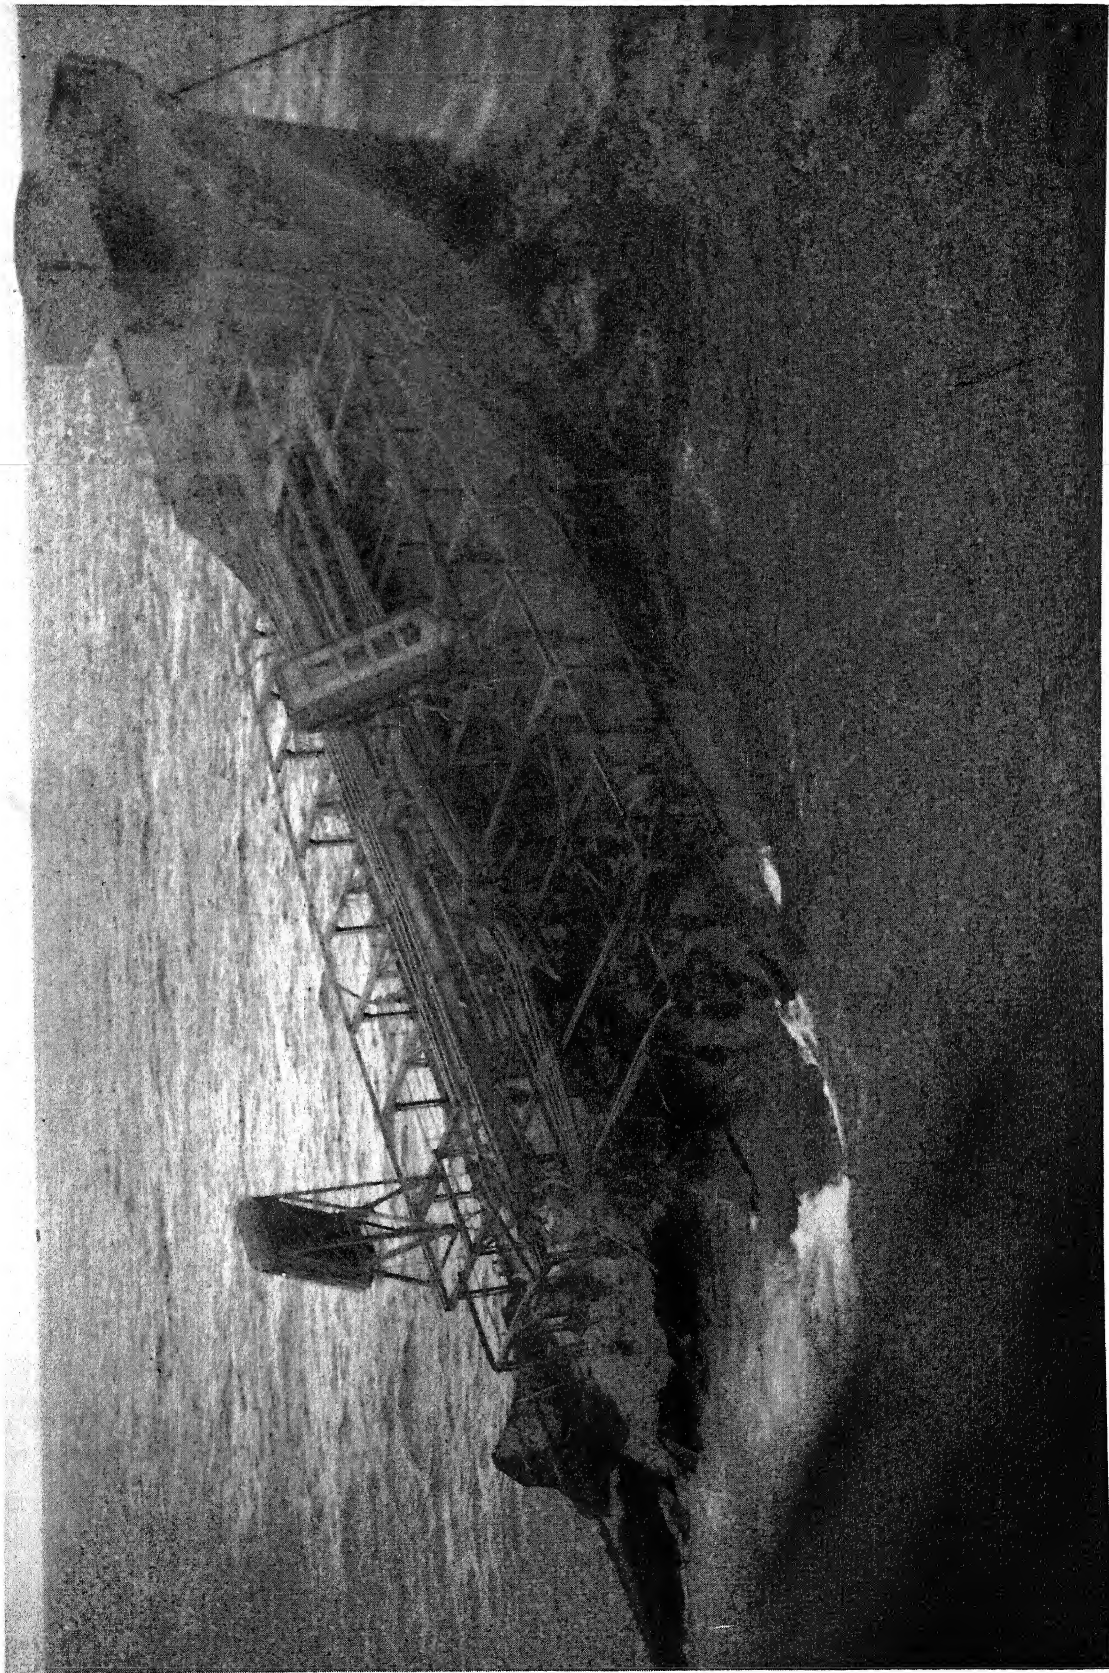
FIGURE 22.—Forward portion of *S. S. Donbass III*.

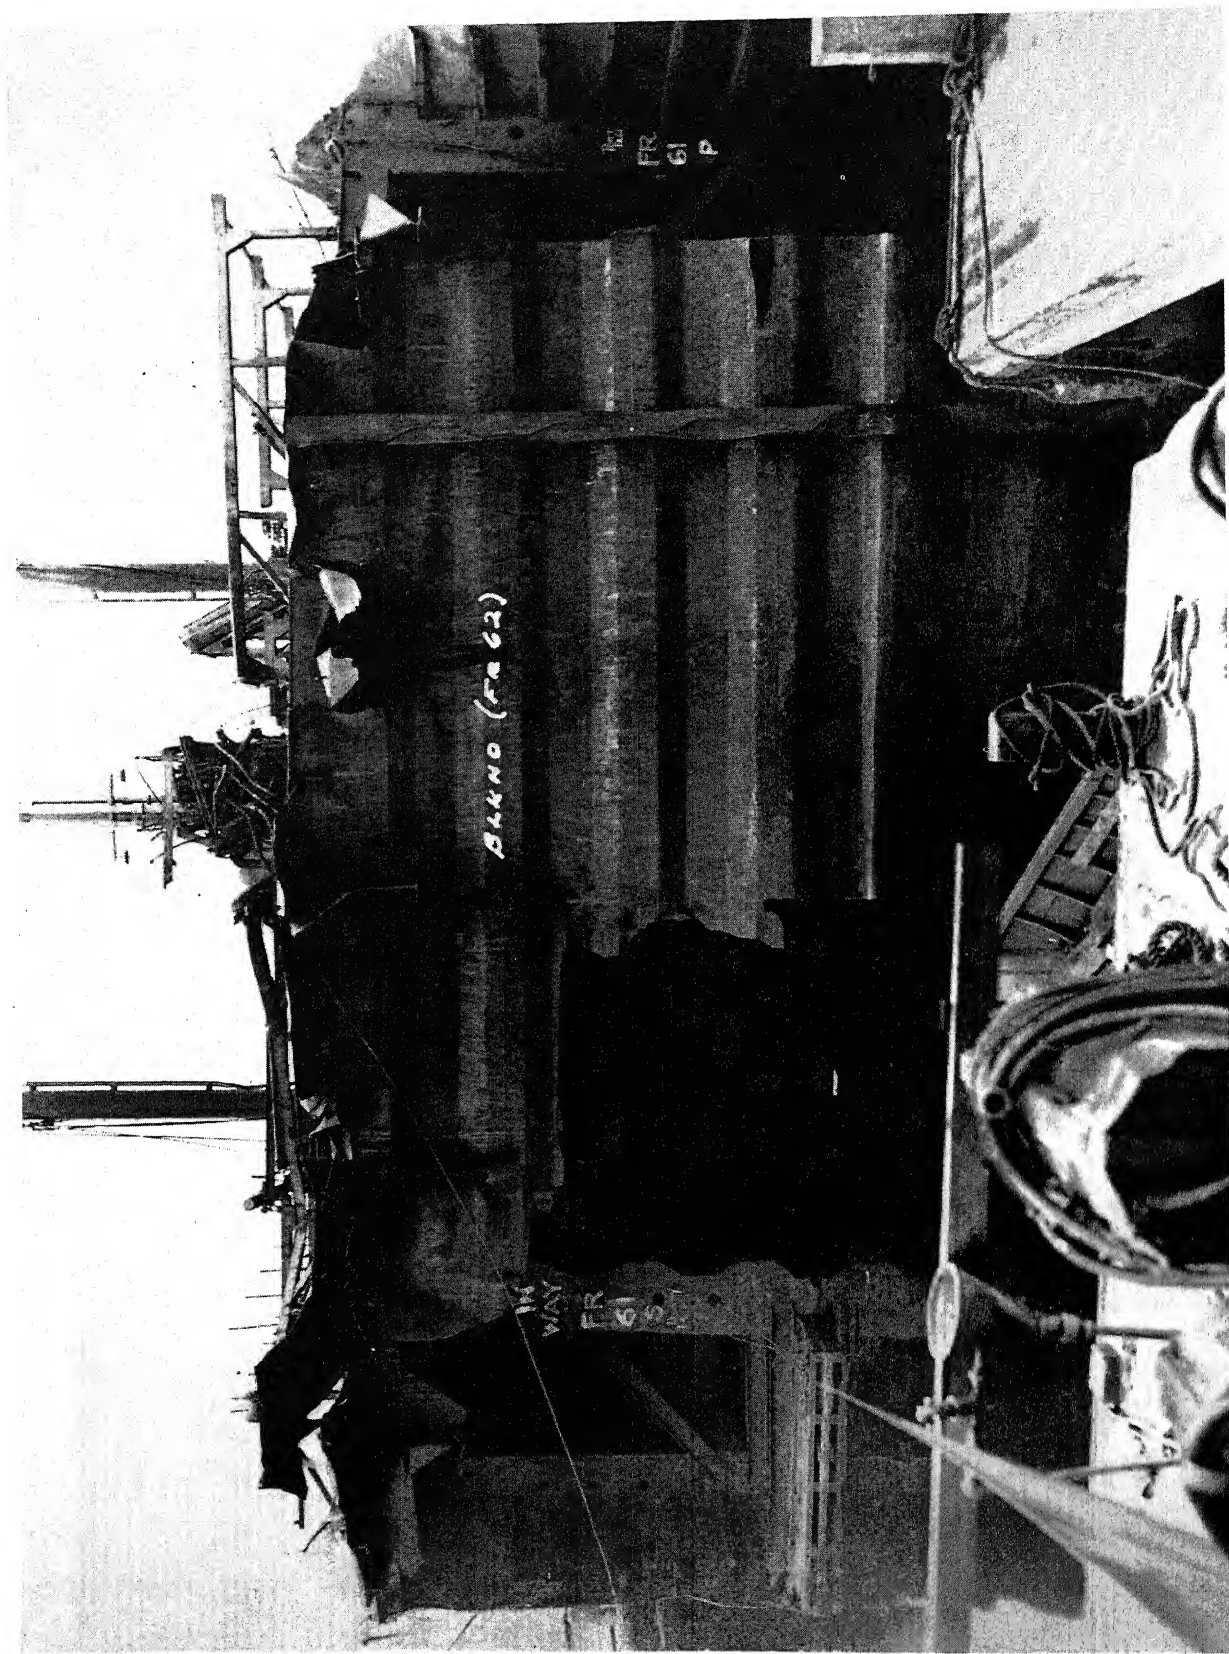
FIGURE 23.—Stern portion of S. S. Donbass III.
